NASA CONTRACTOR  
REPORT

HYDROGEN ENVIRONMENT  
EMBRITTLMENT OF METALS

ROCKETDYNE

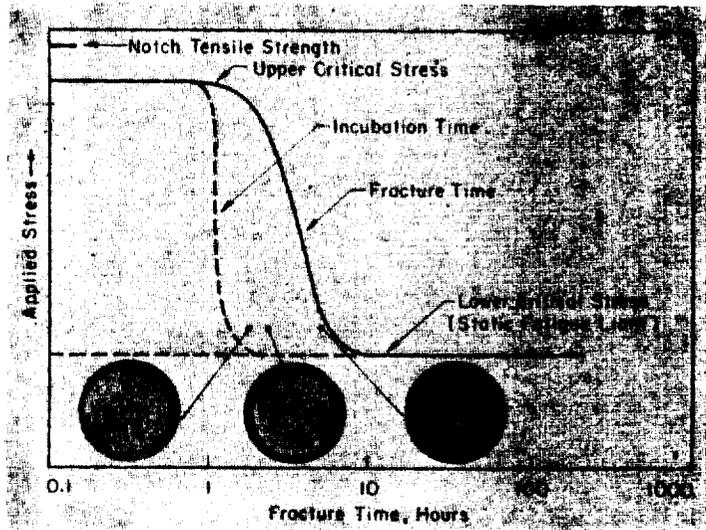
Figure 2. - Failure characteristics of a hydrogenated high-strength steel.

The now traditional representation of delayed failure due to internal hydrogen is shown in Fig. 2. The essential features as stated by Troiano (Ref. 6) are:

1. The notch tensile strength may be less than normal and directly reflects the loss of ductility due to hydrogen.
2. Delayed failure may occur over a wide range of applied stress.
3. There is only a slight dependence of the time to failure upon the applied stress.

4. Perhaps the most significant characteristic of this stress rupture relationship lies in the fact that there is a minimum critical value below which failure does not occur."

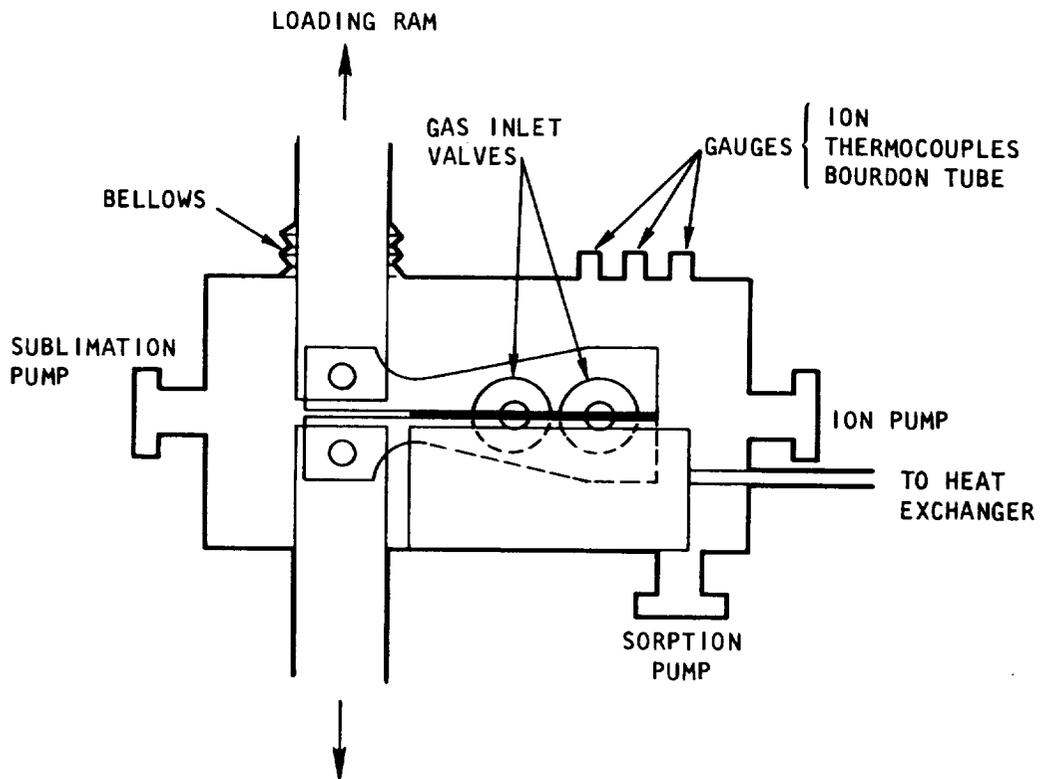
Figure 5. High-vacuum system used for performing tests in controlled low-pressure environments (ref. 30)

The apparatus used for performing tests in low-pressure (less than 1 atmosphere) hydrogen are an adaptation of vacuum testing systems. An example of a versatile low-pressure test apparatus is that developed by Marcus and Stocker (Ref. 30). The apparatus is illustrated in Fig. 5, and is basically a high-vacuum system with gas inlet valves. The apparatus was constructed to follow

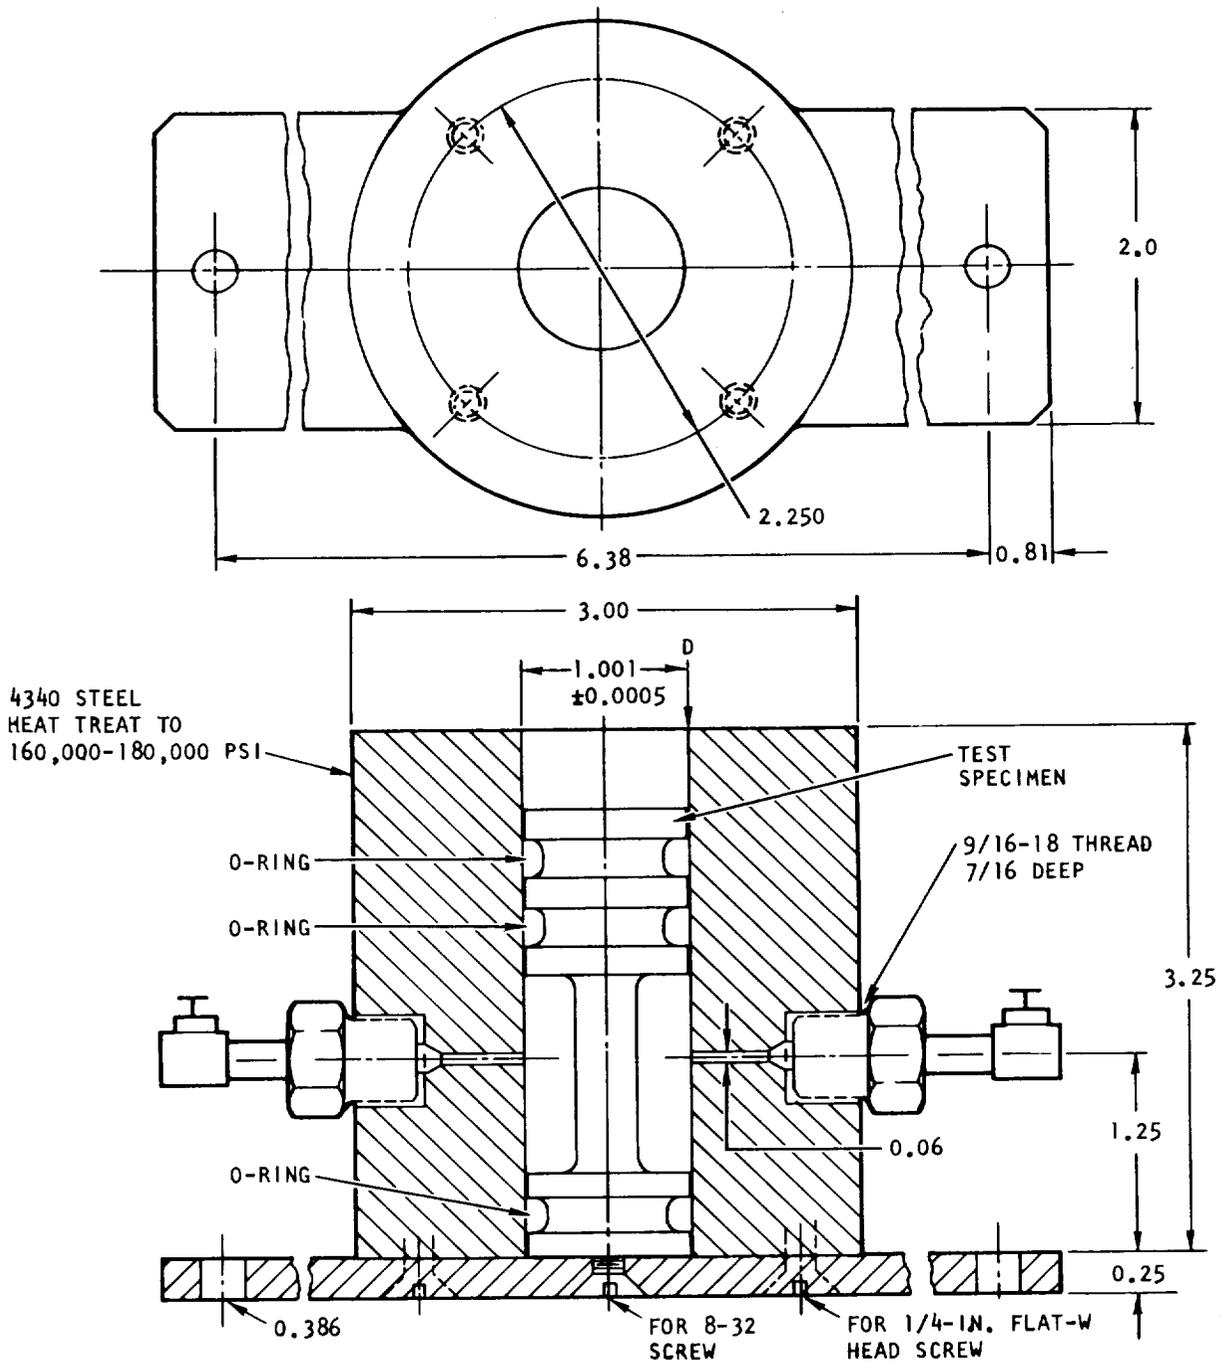
Figure 6. - Apparatus for tensile-testing specimens in high-pressure hydrogen.  
The system pressure is the only tensile force applied.

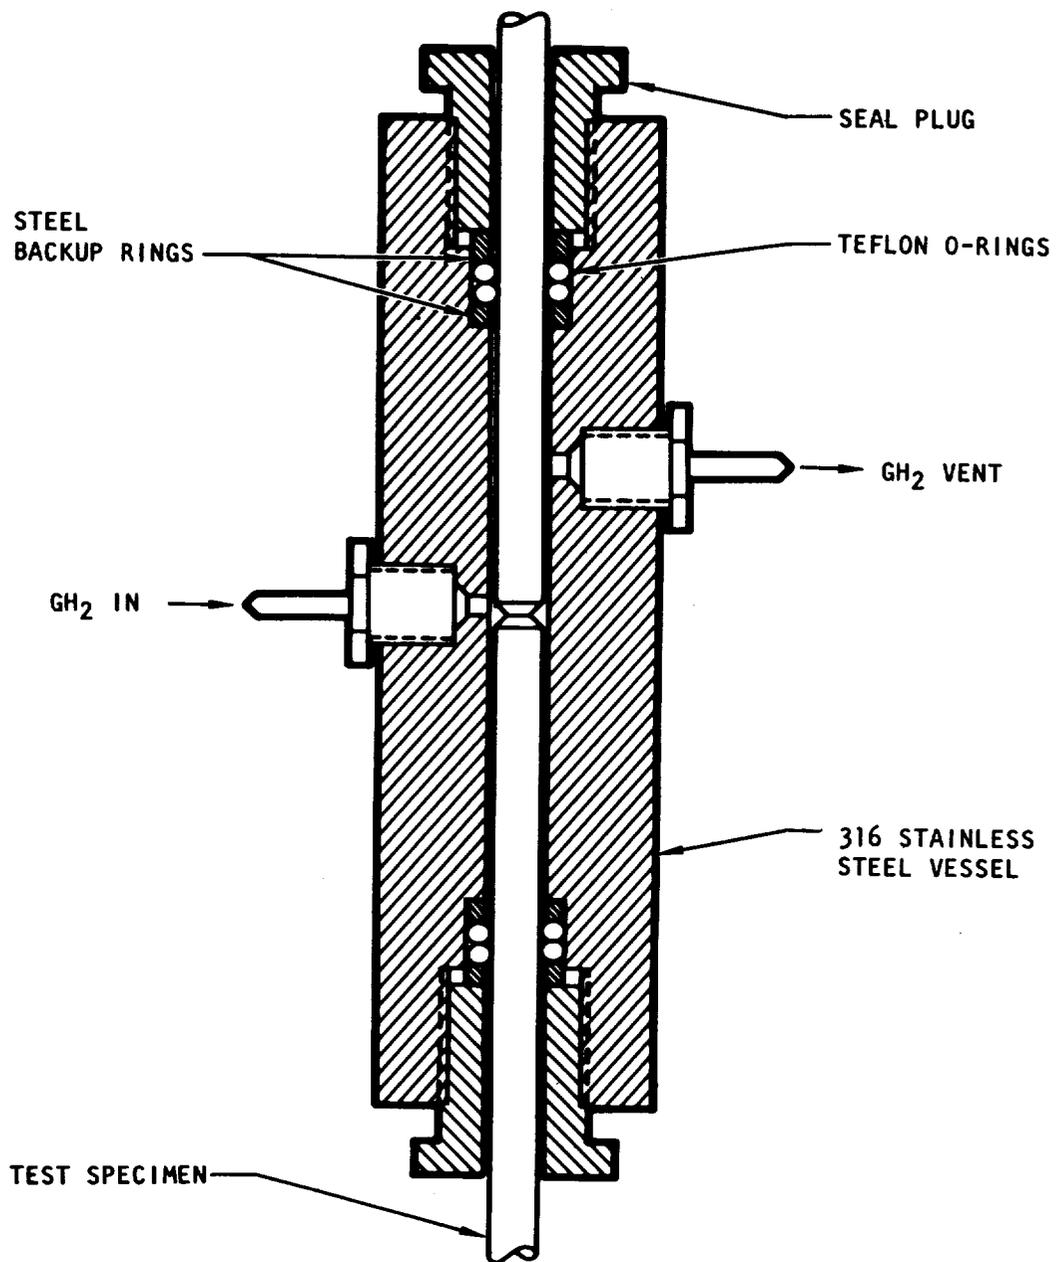
Figure 7. - Test vessel with cylindrical specimen (ref. 7).

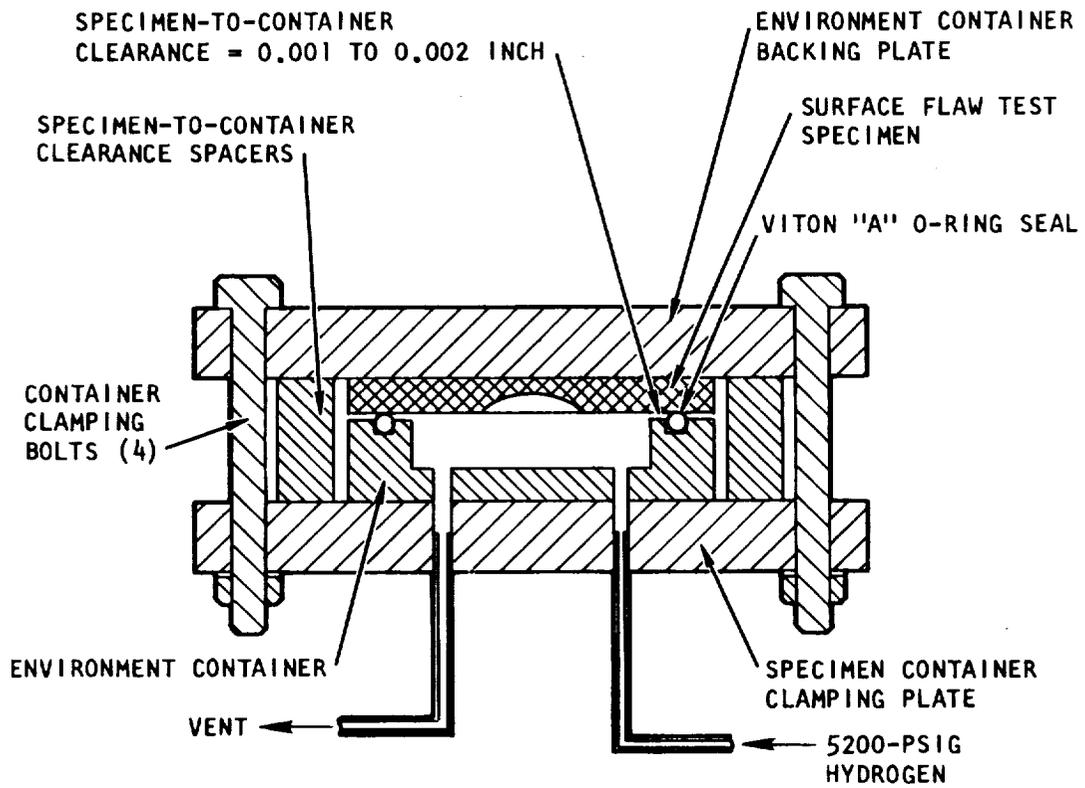
Figure 9. Sheet specimen clamped in frame with surface flaw exposed to 5200-psig hydrogen.

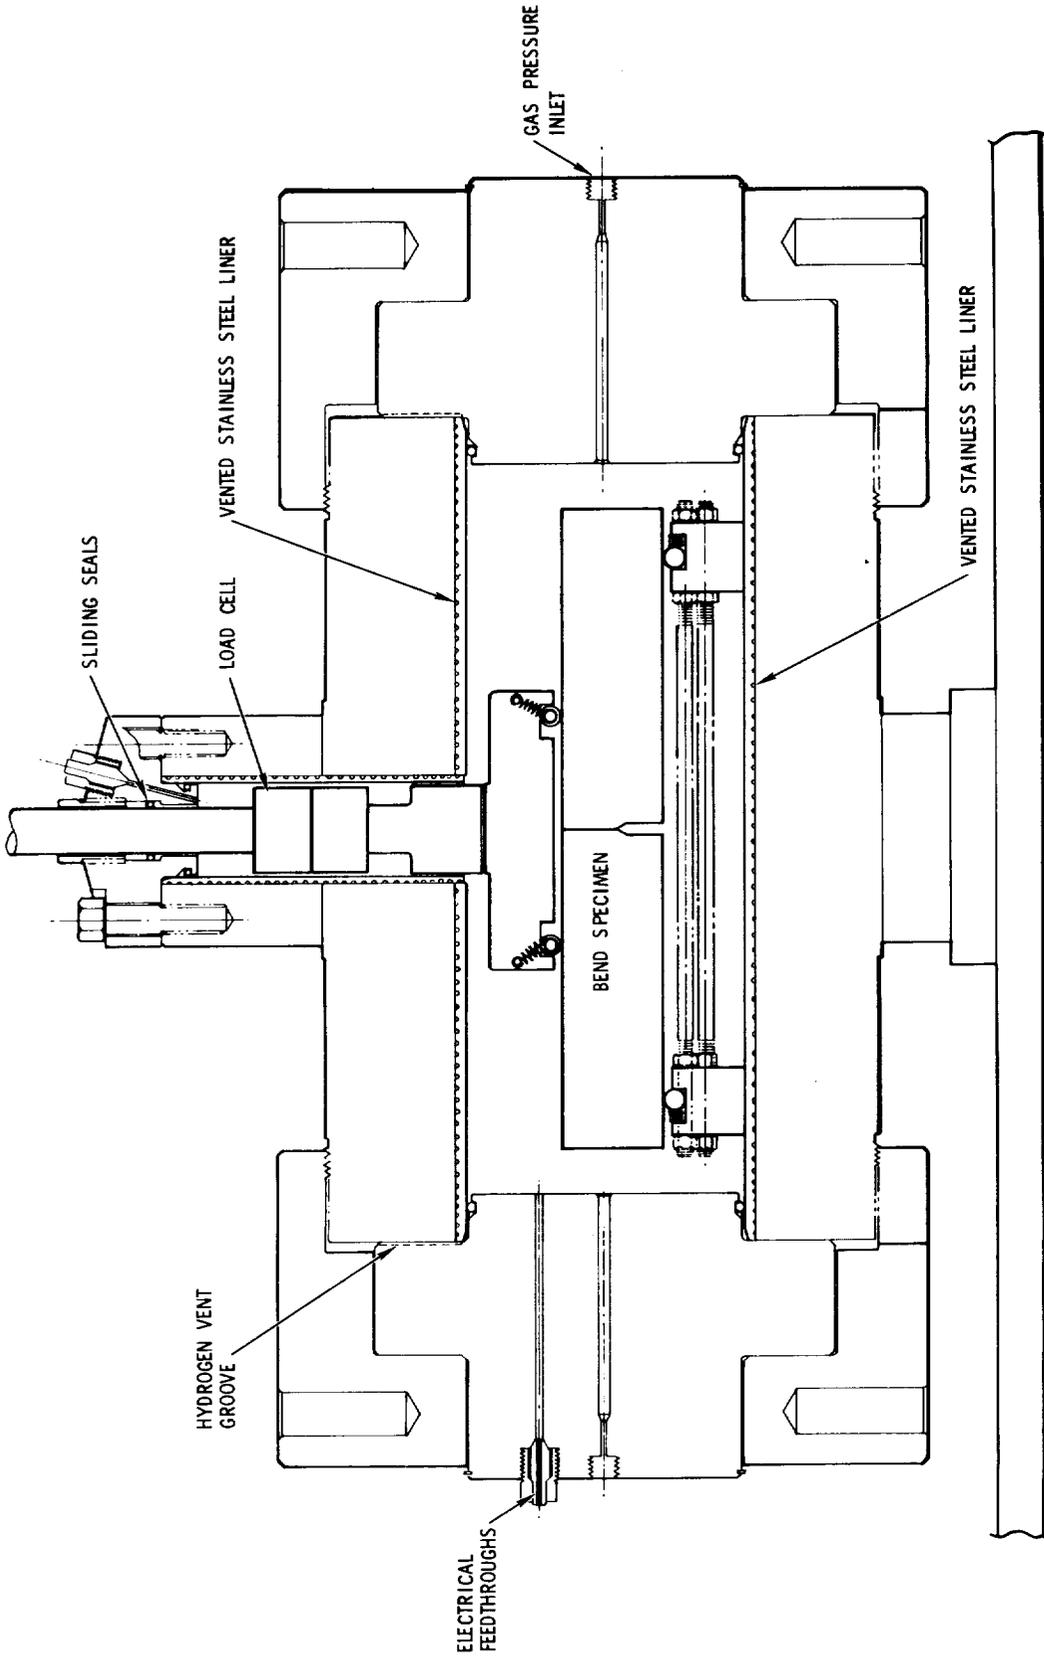
Figure 10. Vessel for performing bend tests in 15000-psi hydrogen environments.

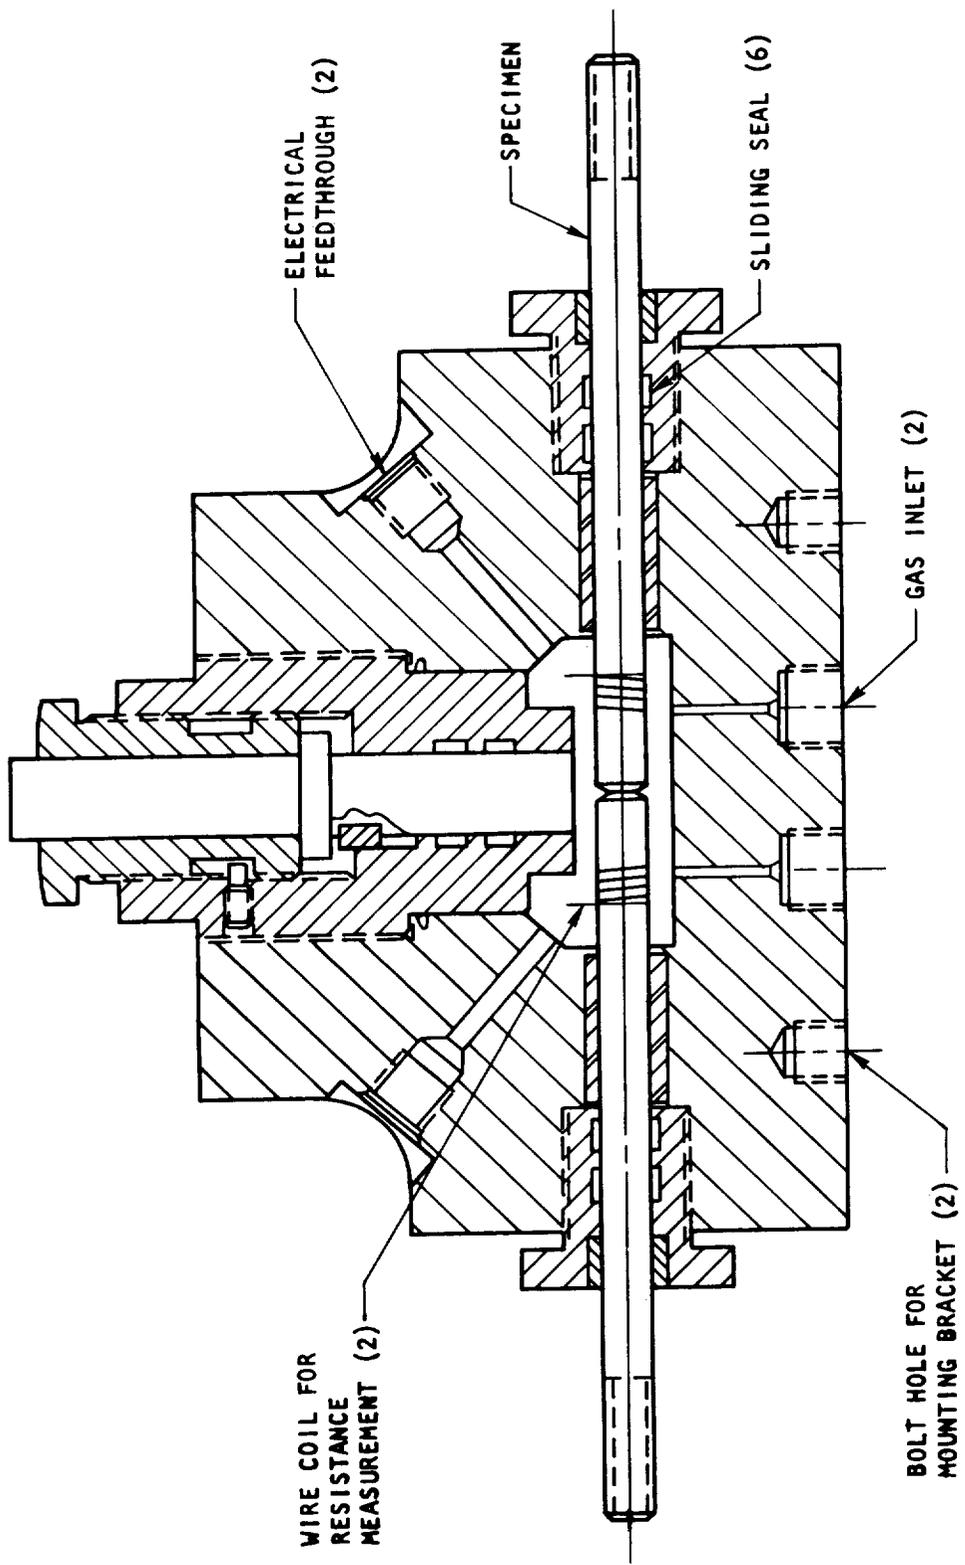
Figure 11. Device for abrading tensile specimens in high-pressure hydrogen (ref. 7).

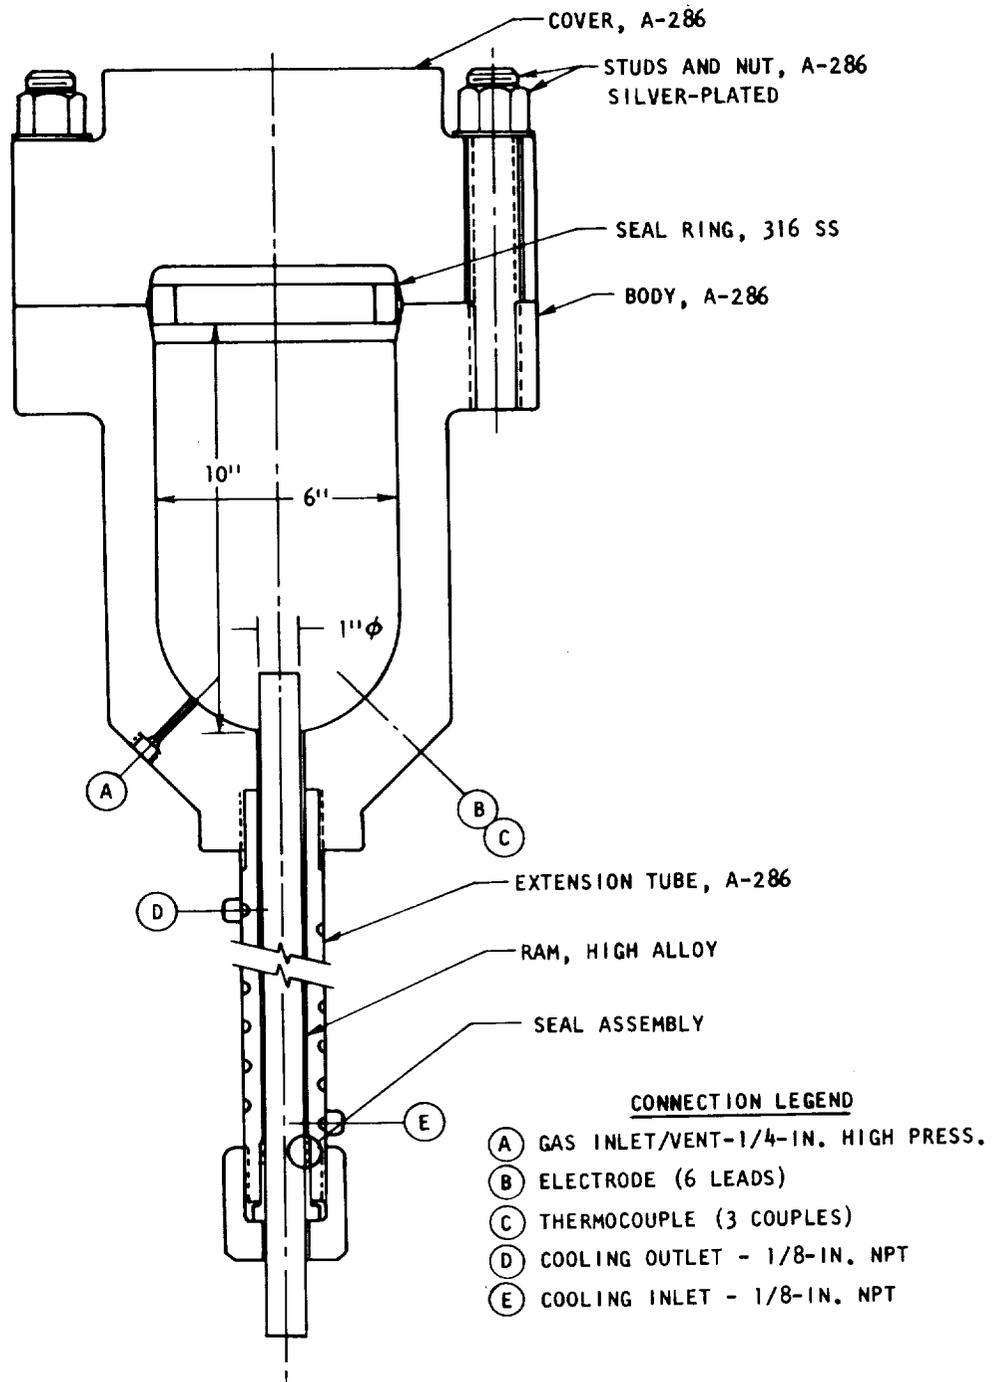
Figure 12. Pressure vessel used to test modified WOL specimens in high-pressure hydrogen at from  $-320^{\circ}$  to  $1200^{\circ}$  F.

The same basic method can be used for elevated-temperature testing in high-pressure hydrogen. Figure 12 is a schematic of a vessel to be used at Rocketdyne for performing fracture toughness tests on compact-tension and modified WOL specimens in 5000-psi hydrogen at cryogenic and elevated temperatures (-320° to 1200°F). The test specimens are anchored to the vessel cover and loaded by the ram, which extends through sliding seals located in the water-cooled necked region. It is advisable that the sliding seals be maintained at room temperature during cryogenic- and elevated-temperature testing because of increased sliding friction at cryogenic temperatures and the temperature limitations of sliding seal materials at elevated temperatures.

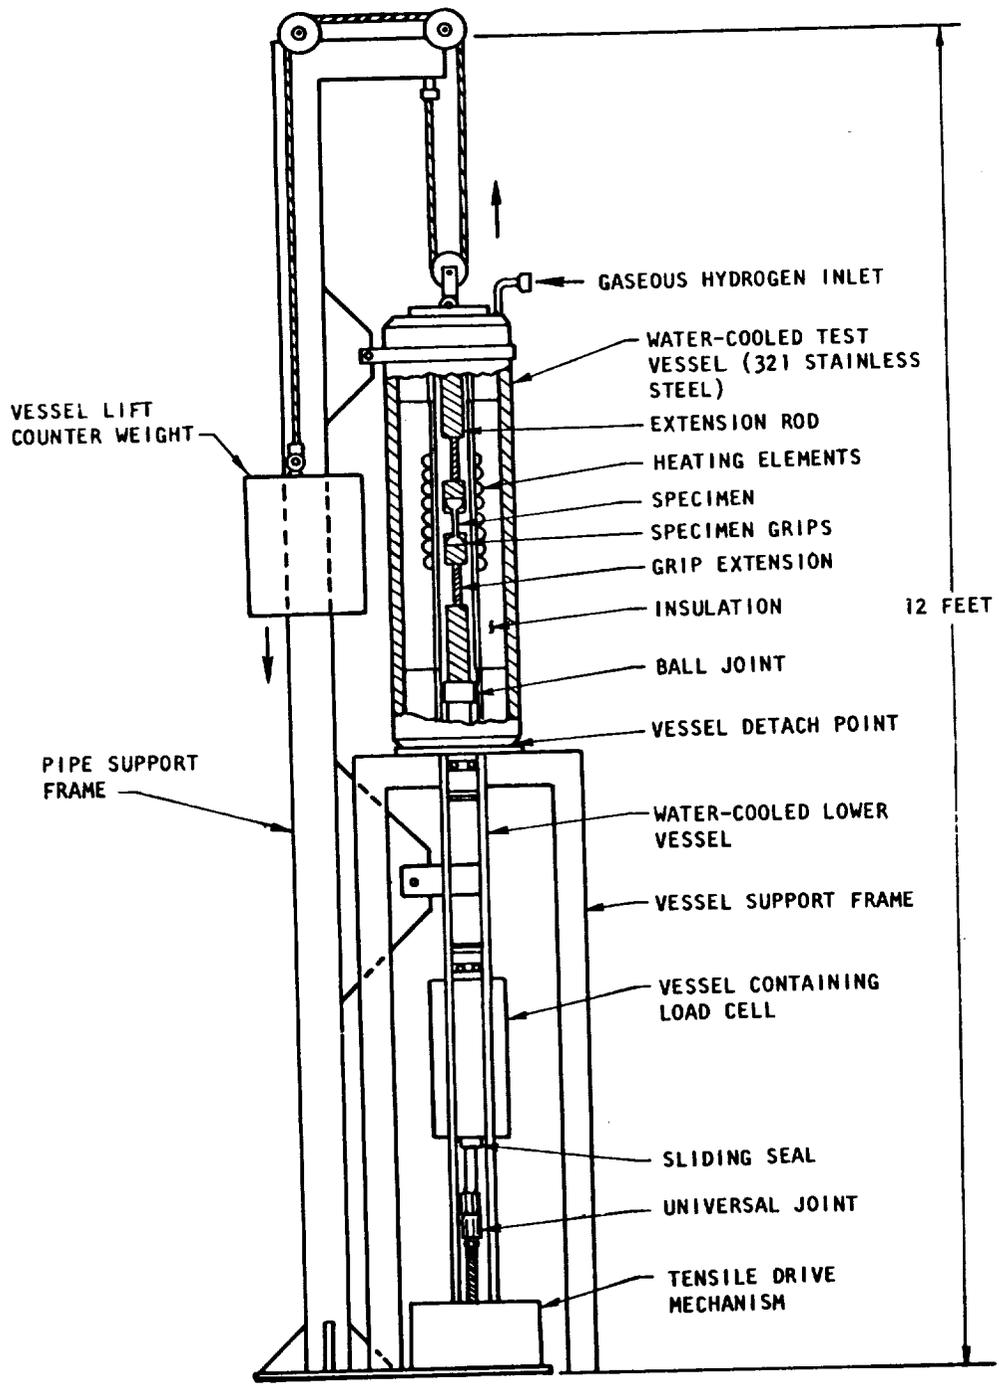
Figure 13. Apparatus for tensile-testing cylindrical specimens in high-pressure hydrogen at elevated temperatures.

The apparatus used at Rocketdyne for performing tensile tests on cylindrical specimens at temperatures up to 2000°F is shown schematically in Fig. 13 (Ref. 26). The test vessel has a double wall for water cooling, and includes a tube which separates the specimen cavity from the furnace cavity. A water-cooled lower extension of the vessel contains a load cell. The specimen cavity, furnace cavity, and load cell cavity are separated from each other by Viton-A O-ring seals. The same gas at the same pressures is fed into the three cavities during the tests in order to minimize gas passage across the O-rings. Self-aligning ball joints are located inside the vessel to ensure that a uniaxial load is applied to the specimen.

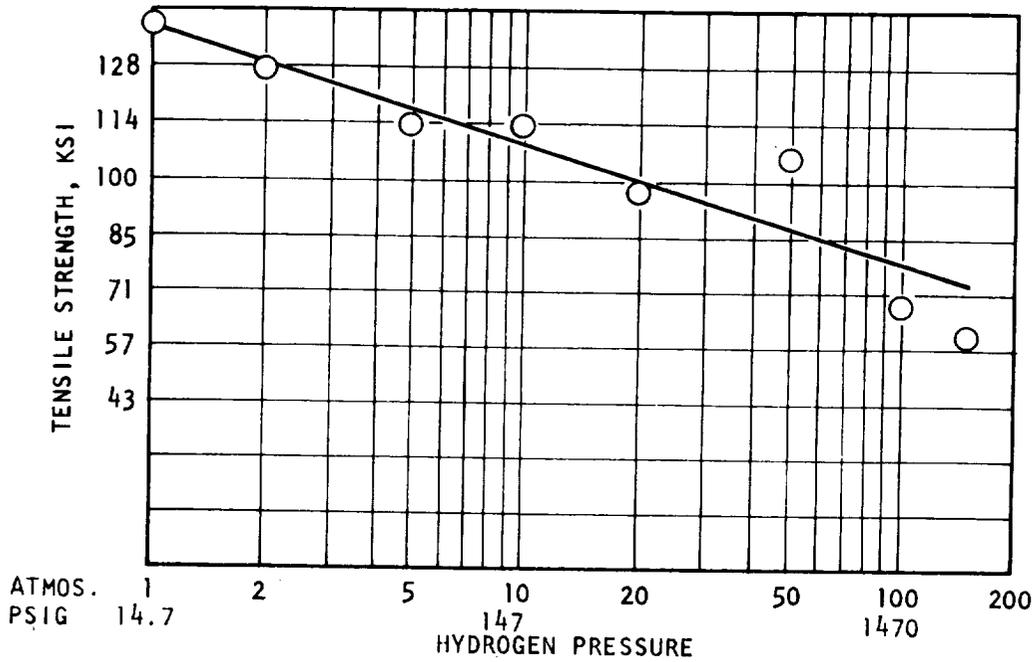
Figure 14. Effect of hydrogen pressure vs tensile strength.

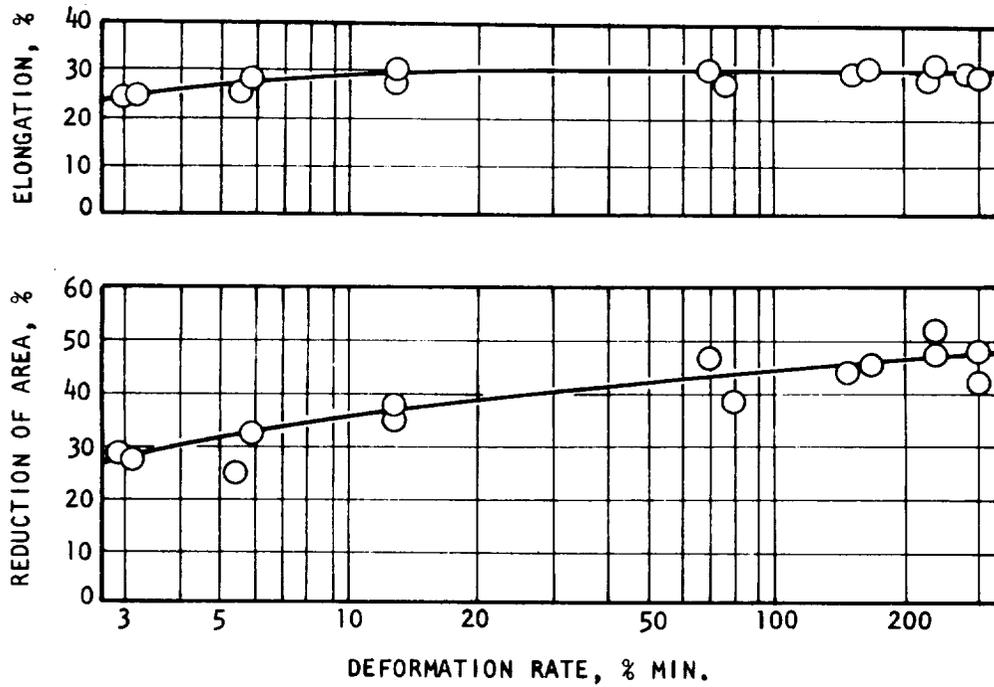
Figure 15. Effect of deformation rate on elongation (in 5D) and reduction in area (normalized CK22 steel, exposed to hydrogen pressure of 2205 psig).

In a second series of tests utilizing cold-drawn 0.22% carbon steel, Hofmann and Rauls (Ref. 41) investigated the effect on the degree of embrittlement occasioned by various hydrogen pressures and various additions of oxygen and nitrogen to the high-pressure hydrogen. This latter topic will be discussed later. A lowering of the ultimate tensile strength and rupture elongation with increasing hydrogen pressure was reported (Fig. 14). These authors also investigated (Ref. 42) the effect of strain rate on ductility at a pressure of 2205 psig (Fig. 15). The

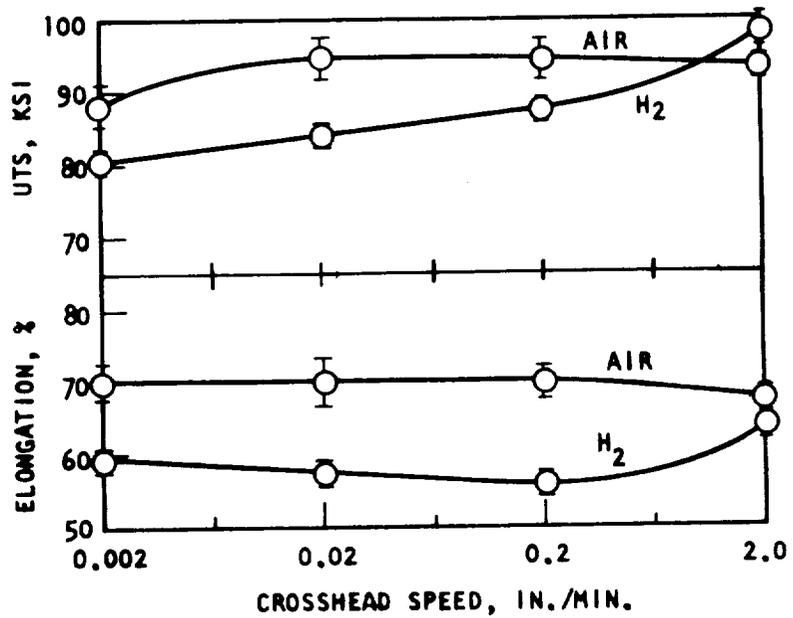
Figure 18. Tensile strength and elongation versus crosshead speed for notched ( $k_t$  4.0) specimens of 304L stainless steel tested in air and 10000 psi hydrogen at various strain rates. (Gage length is assumed to be 0.0985 in.)

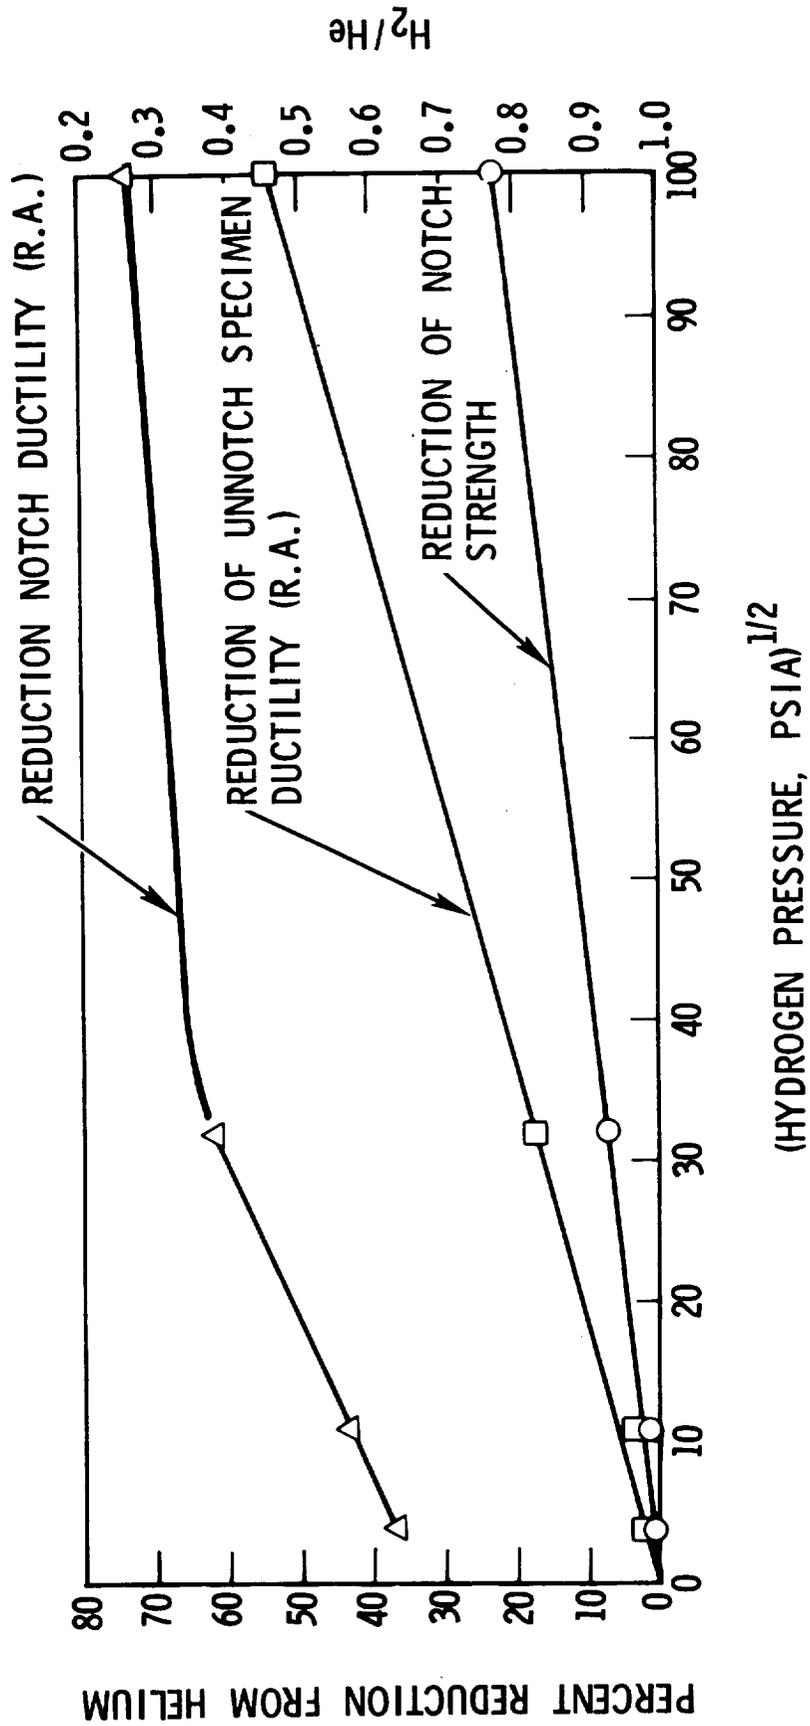
Figure 19. Reduction in tensile properties of ASTM A533-B specimens in hydrogen compared with that in helium as a function of hydrogen pressure.

The notch strength of specimens from heat treatment 2 was reduced approximately 40 percent in 1000-psig hydrogen, compared to approximately 55 percent in 10 000-psig hydrogen when compared to similar helium pressures. There was a small reduction in ductility of notched specimens from exposure to 1000-psig hydrogen, while the notched specimens tested in 10 000-psig

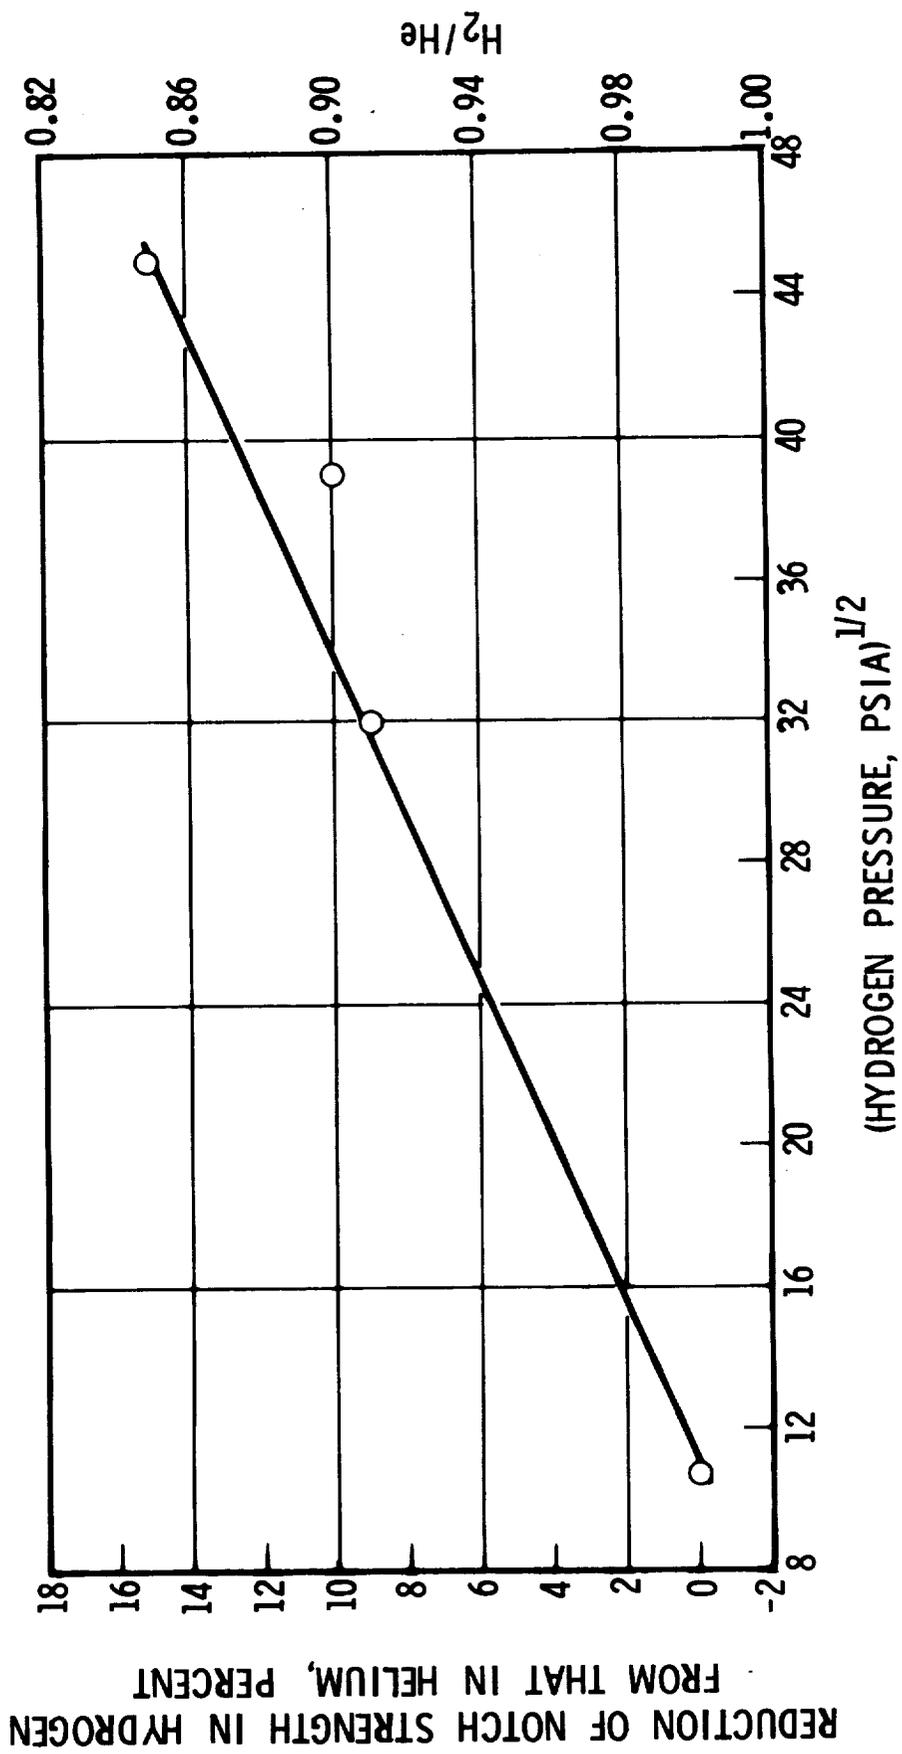
Figure 20. Reduction of notch strength of Inconel 718 in hydrogen compared with that in helium as a function of hydrogen pressure (room temperature).

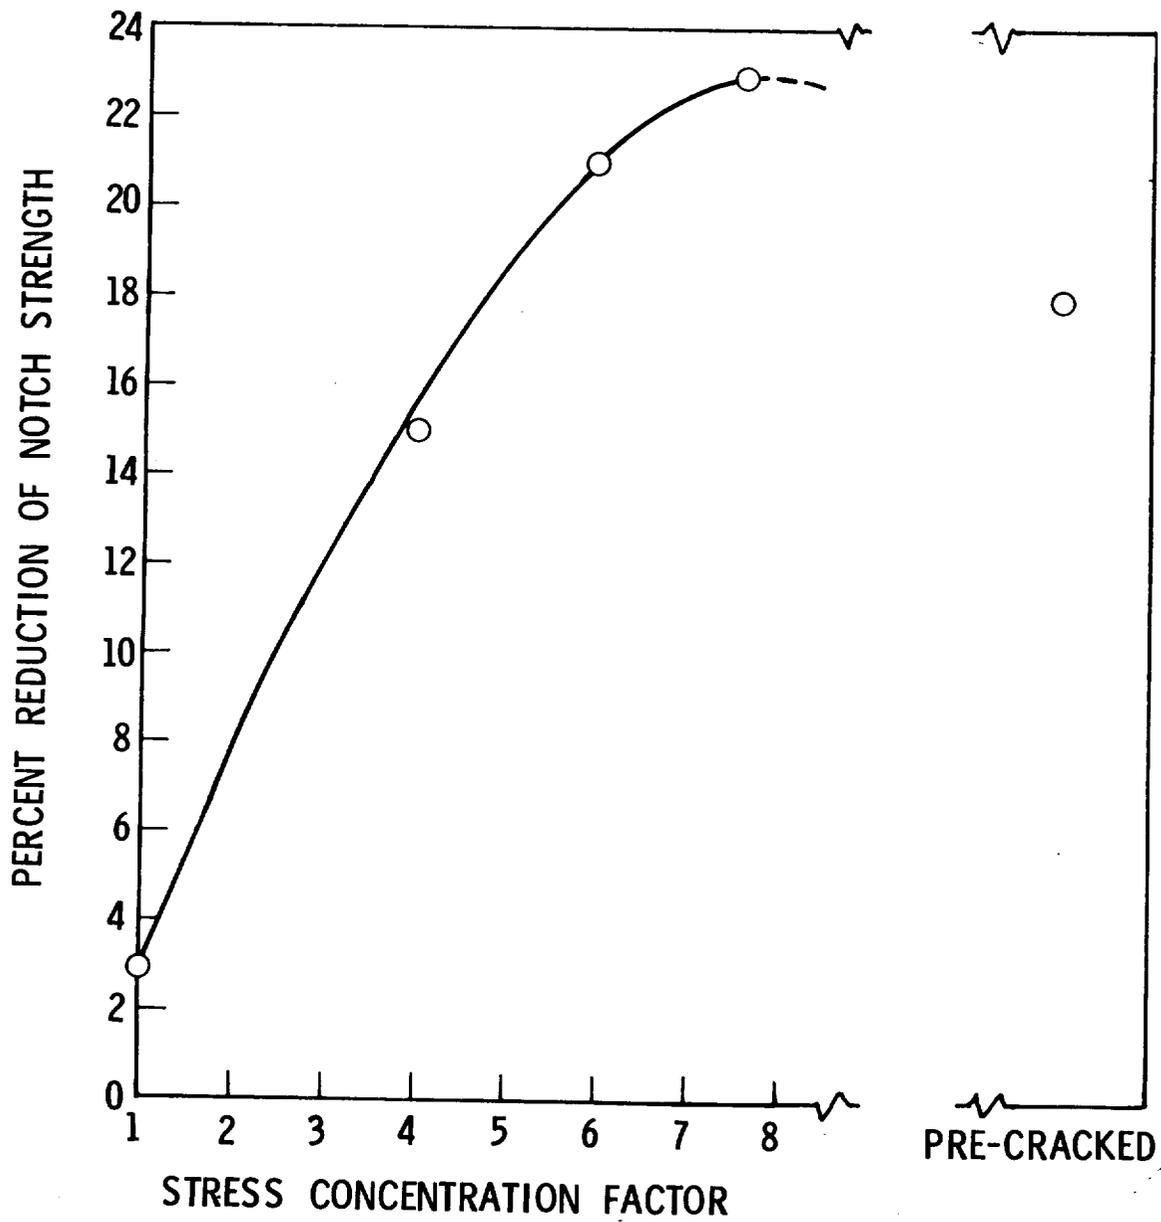
Figure 21. Reduction of Strength as a Function of Notch Severity for ASTM A533-B (ref. 7)

Also plotted in Fig. 21 and 22 is the reduction of strength for fatigue precracked specimens. The  $K_t$  value for a notch containing a fatigue-induced crack was arbitrarily assumed by Walter and Chandler to be between 19 and 20.

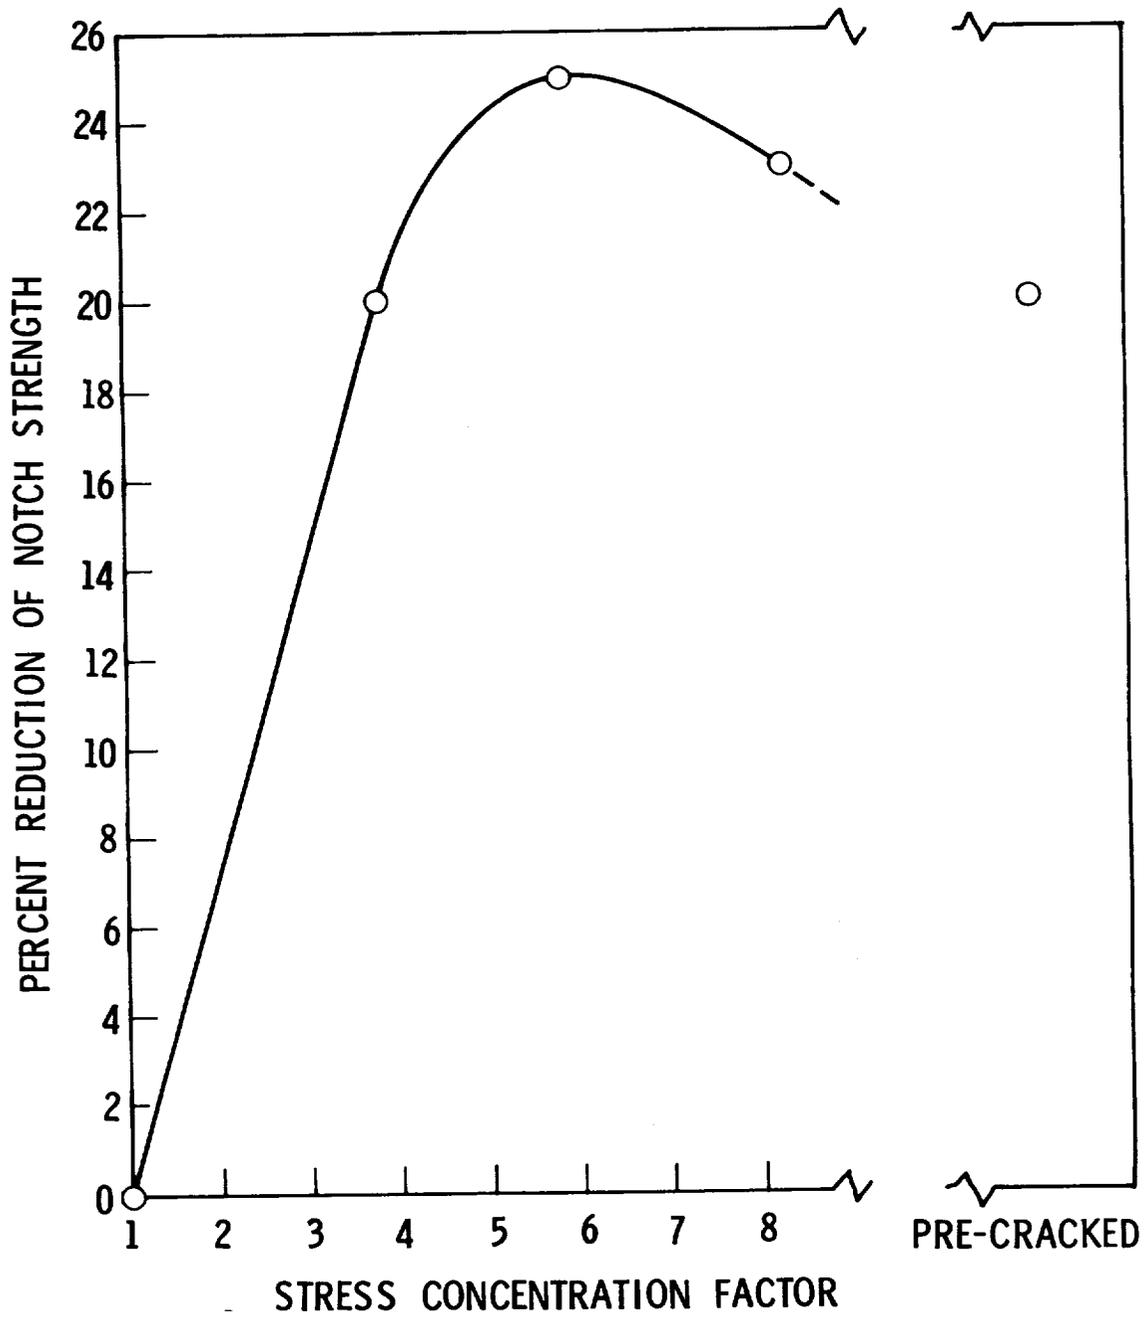
Figure 22. Reduction in Strength of ASTM A-517 as a function of notch severity.

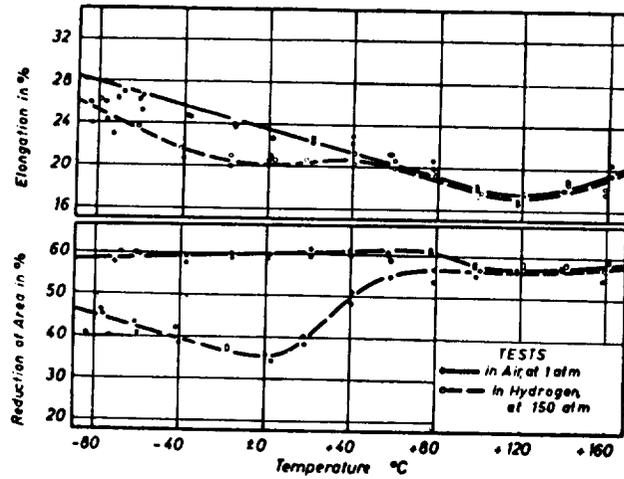
Figure 23. Effect of temperature on elongation and reduction of area of cold-drawn CK 22 steel in air and in hydrogen.

Hofmann and Rauls investigated the effect of temperature on hydrogen-environment embrittlement between  $-130^{\circ}\text{F}$  ( $-90^{\circ}\text{C}$ ) and  $338^{\circ}\text{F}$  ( $170^{\circ}\text{C}$ ) at 2205 psig pressure for cold-drawn and normalized CK 22. The tensile deformation rate was 5%/min. No effect on the ultimate tensile strength was observed at any of the test temperatures. The effect on ductility (percent elongation and reduction of area), however, was pronounced, as shown in Fig. 23 and 24. In the cold-drawn CK 22, the maximum degradation value of reduction of area occurred at  $0^{\circ}\text{C}$  in hydrogen, while in the normalized CK 22, the maximum degradation occurred at  $-40^{\circ}\text{C}$ .

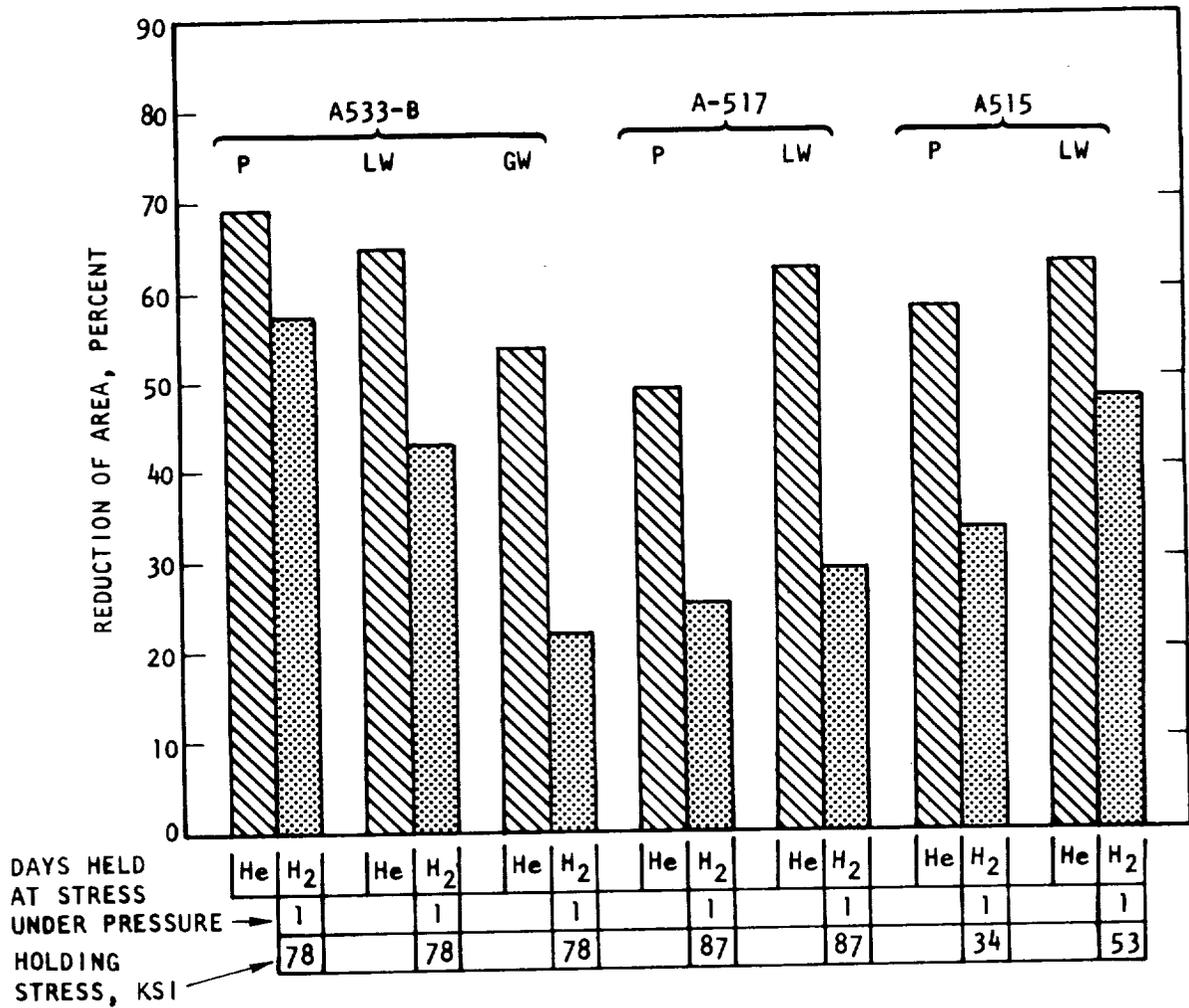
Figure 27. Reduction of area of unnotched parent metal and weld specimens in 10000-psi hydrogen and helium. (P = parent metal, LW = longitudinal weld; GW = girth weld.)

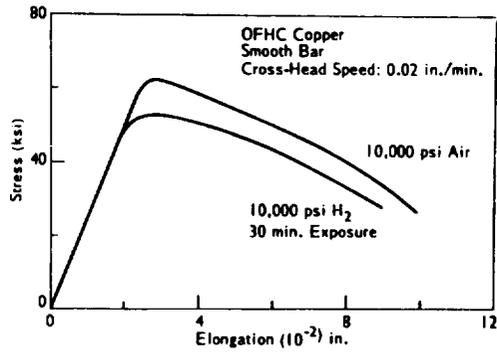
Figure 28. Engineering stress vs elongation observed OFHC copper tested in air and hydrogen.

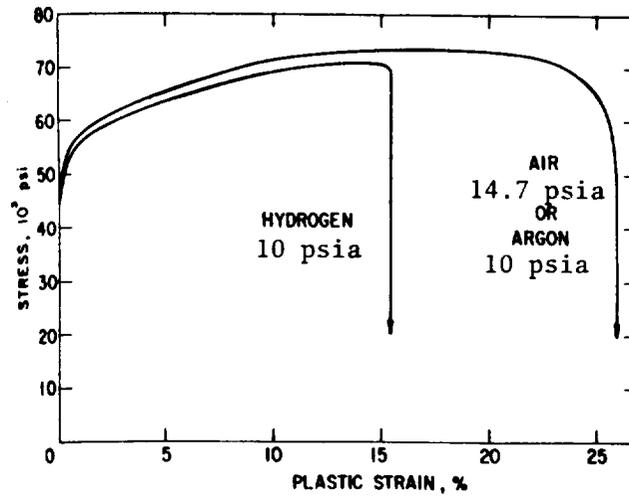
Figure 29. Effect of environment on ductility of iron-3% silicon polycrystals.

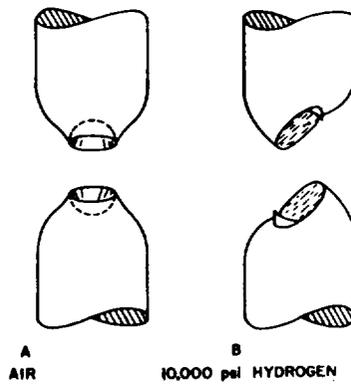
Figure 30. OFHC copper tensile specimens-- smooth-bar fractures in air and in hydrogen at 10000 psig.
